BUREAU OF LAND MANAGEMENT

In Reply Refer To:
UT-040
3809: UTU-67116

This is in reply to your letter, dated April 9, 2002, which provided Hecla's second proposal to control knapweed and obtain final bond release for the Escalante tailings impoundment. The proposal calls for Hecla to be released from liability for knapweed control within the permit area as soon as eradication of the knapweed can be demonstrated, or by 2010, whichever occurs first. Hecla proposes that proof of eradication will be indicated by three knapweed free years, after the removal of the last growing plant.

Project: Hecla Mining Company
 Escalante Mine Tailings Impoundment
 BLM File: UTU-67116
 DOGM File: M/021/004
 Inspection Date: May 1, 2002
 Inspector: Ed Ginouves
 Notes:

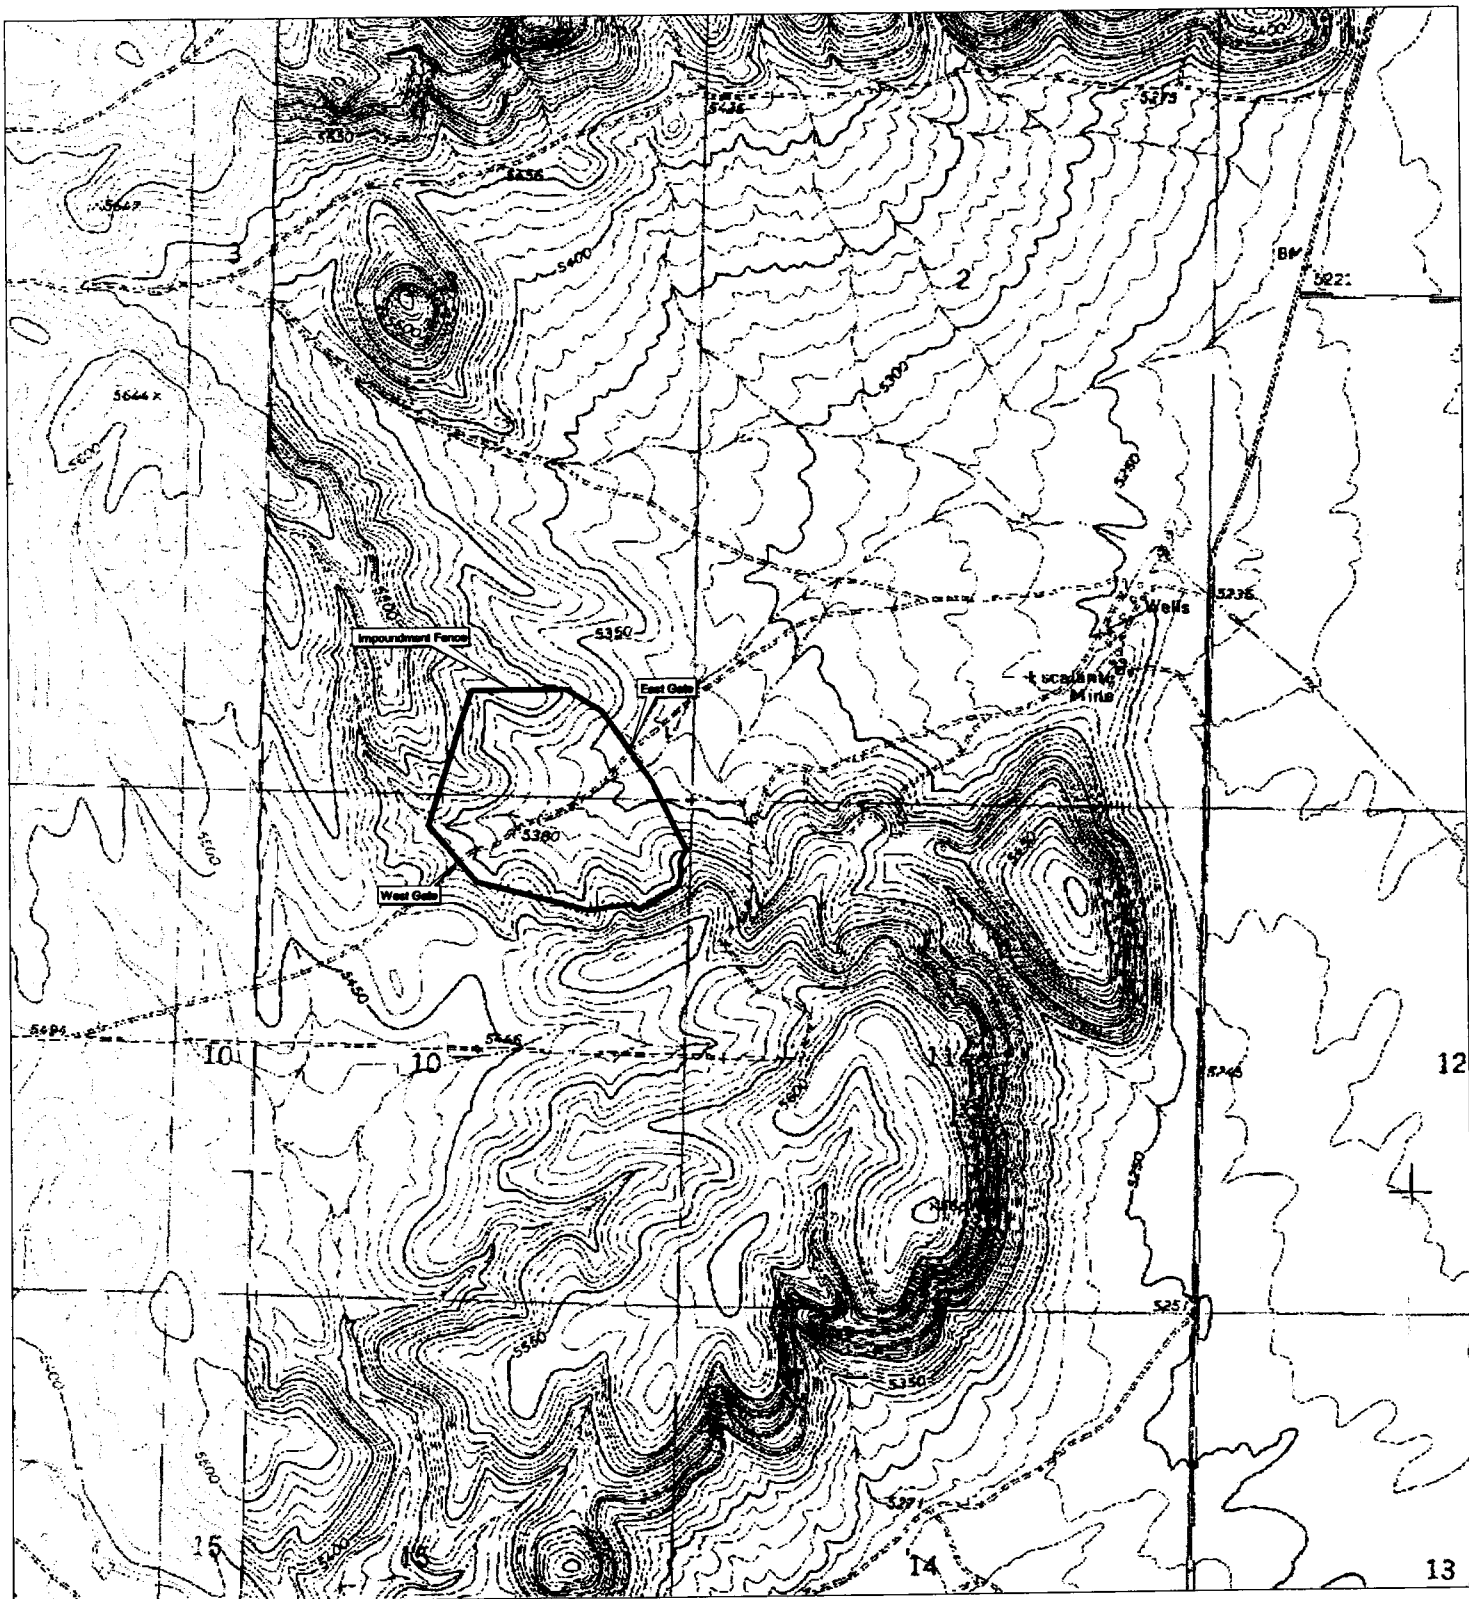
While at the site I GPS'd the 8' fence line enclosing the impoundment area. An ArcView map of that boundary is attached. The fence is in good condition with no breaks found. I also photographed the impoundment area from the ridgeline to the south of the area. Bob and I also drove across a portion of the area that had been stripped for topsoil (located ~¼ mile to the south of the impoundment area) to search for knapweed but none was found.
